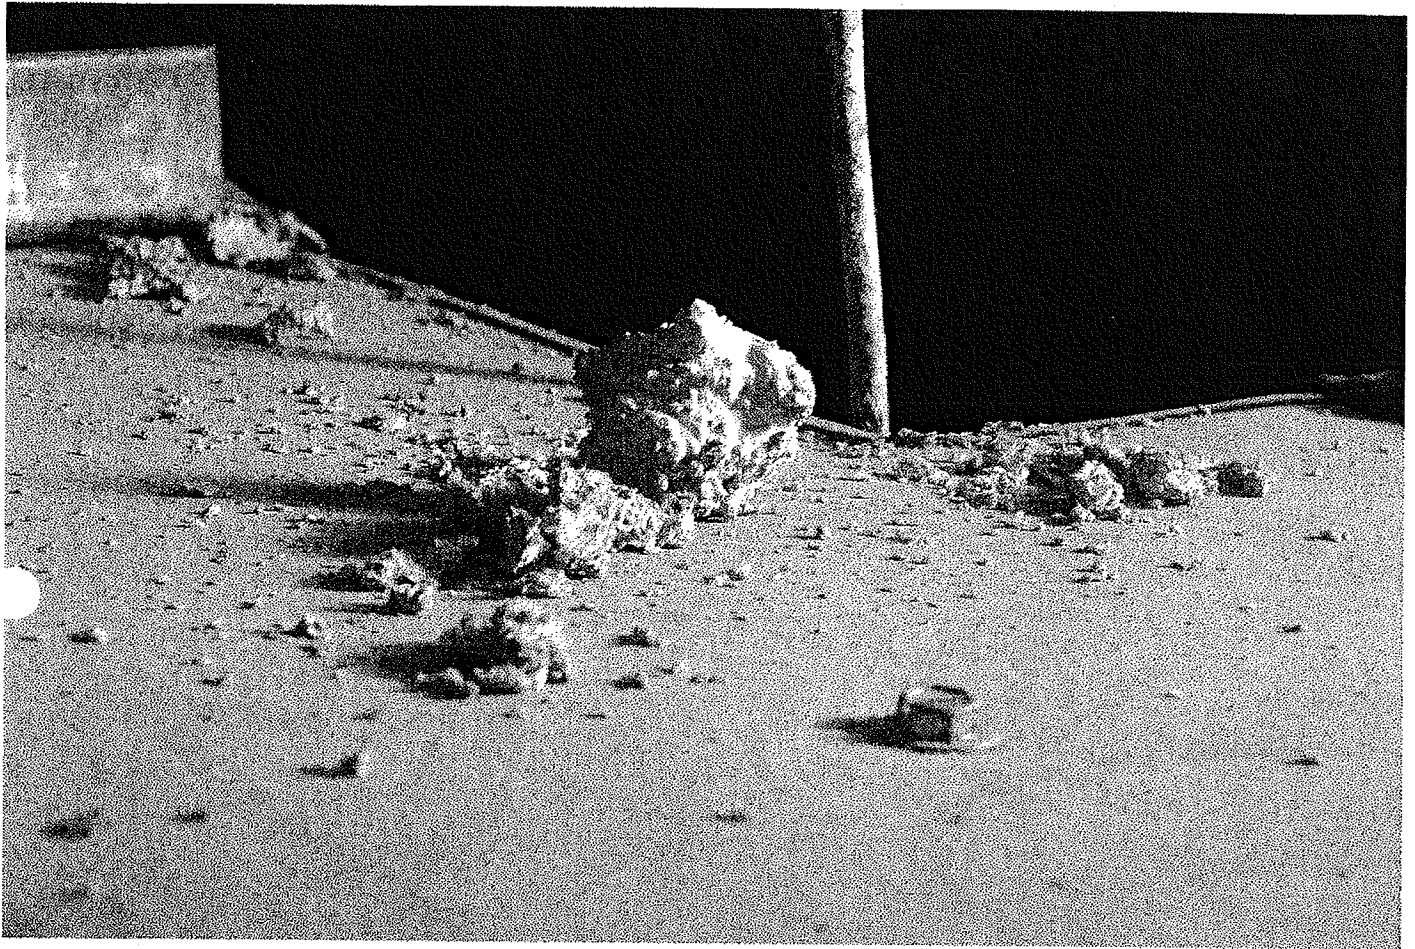
51. 6th floor, adjacent to room S601 - Close-up of delaminated fireproofing debris on top of metal HVAC duct

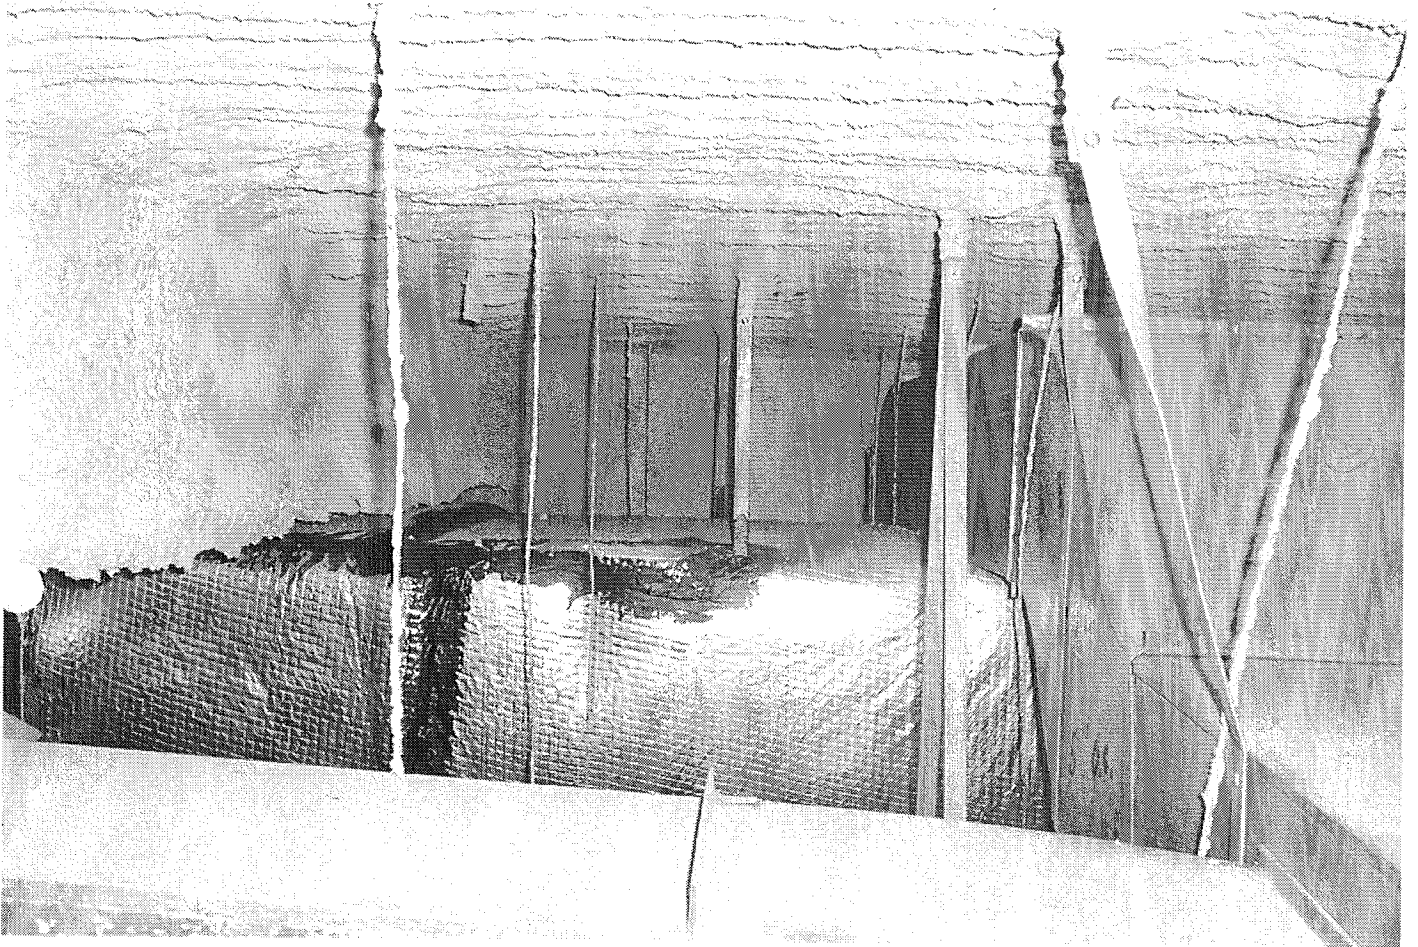
52. 6th floor, adjacent to room S601 - General location of dust sample #6 beneath fireproofed sprayed decking

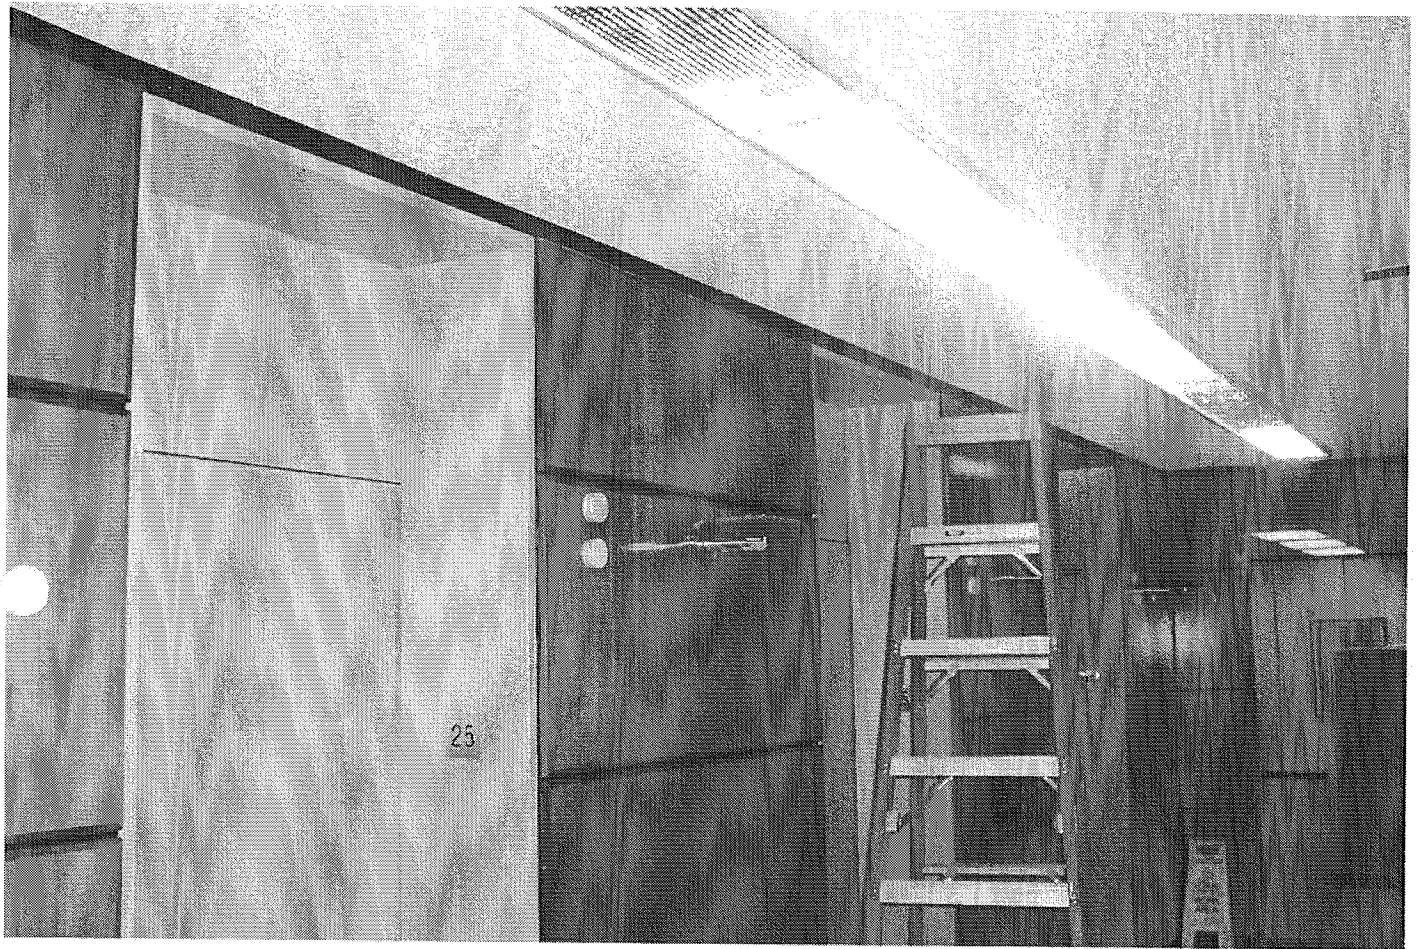
53. 25th floor, northside of elevator lobby - General view of accoustical spray ceiling above elevators

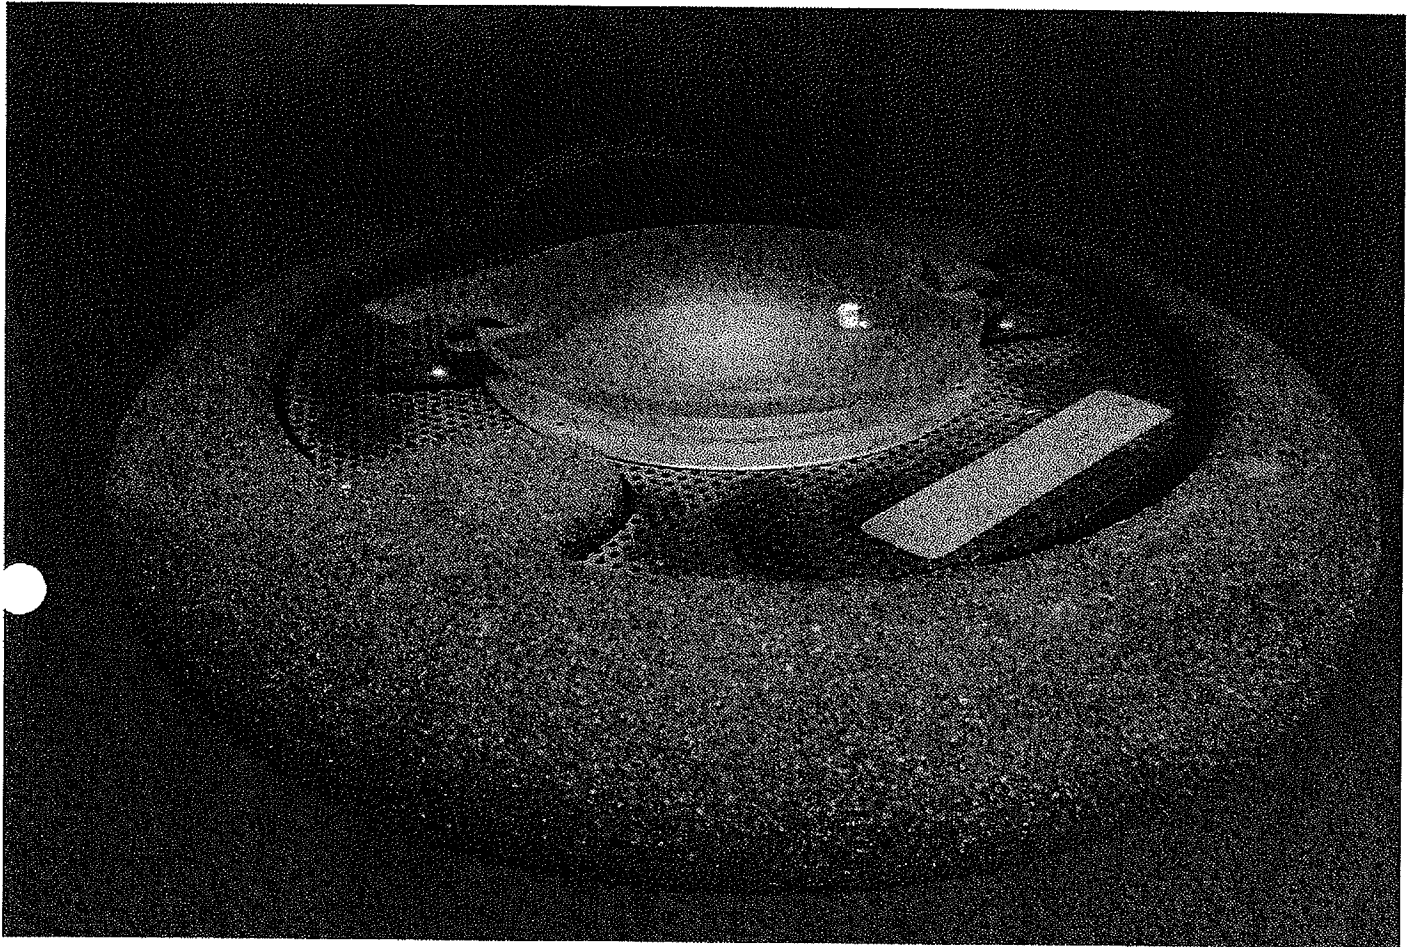
54. 25th floor, northside of elevator lobby - Location of dust sample #7 (top of wall sconce)

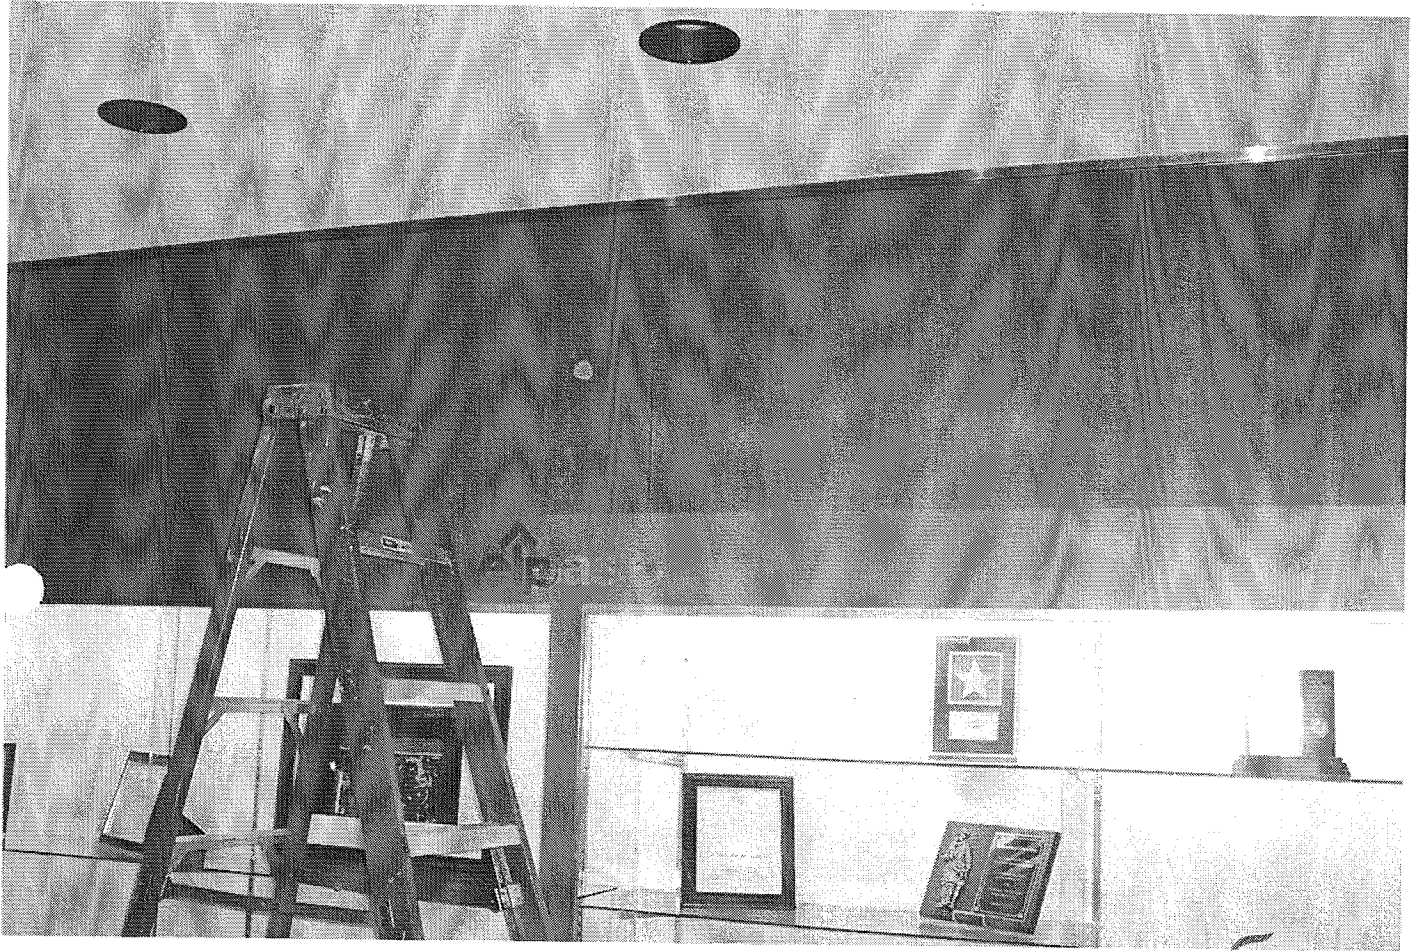
55. Basement, in subterranean tunnel - General view of accoustical spray ceiling above display case in hallway
